2001 Annual Compliance Report Falls City, Texas, Disposal Site

Compliance Summary

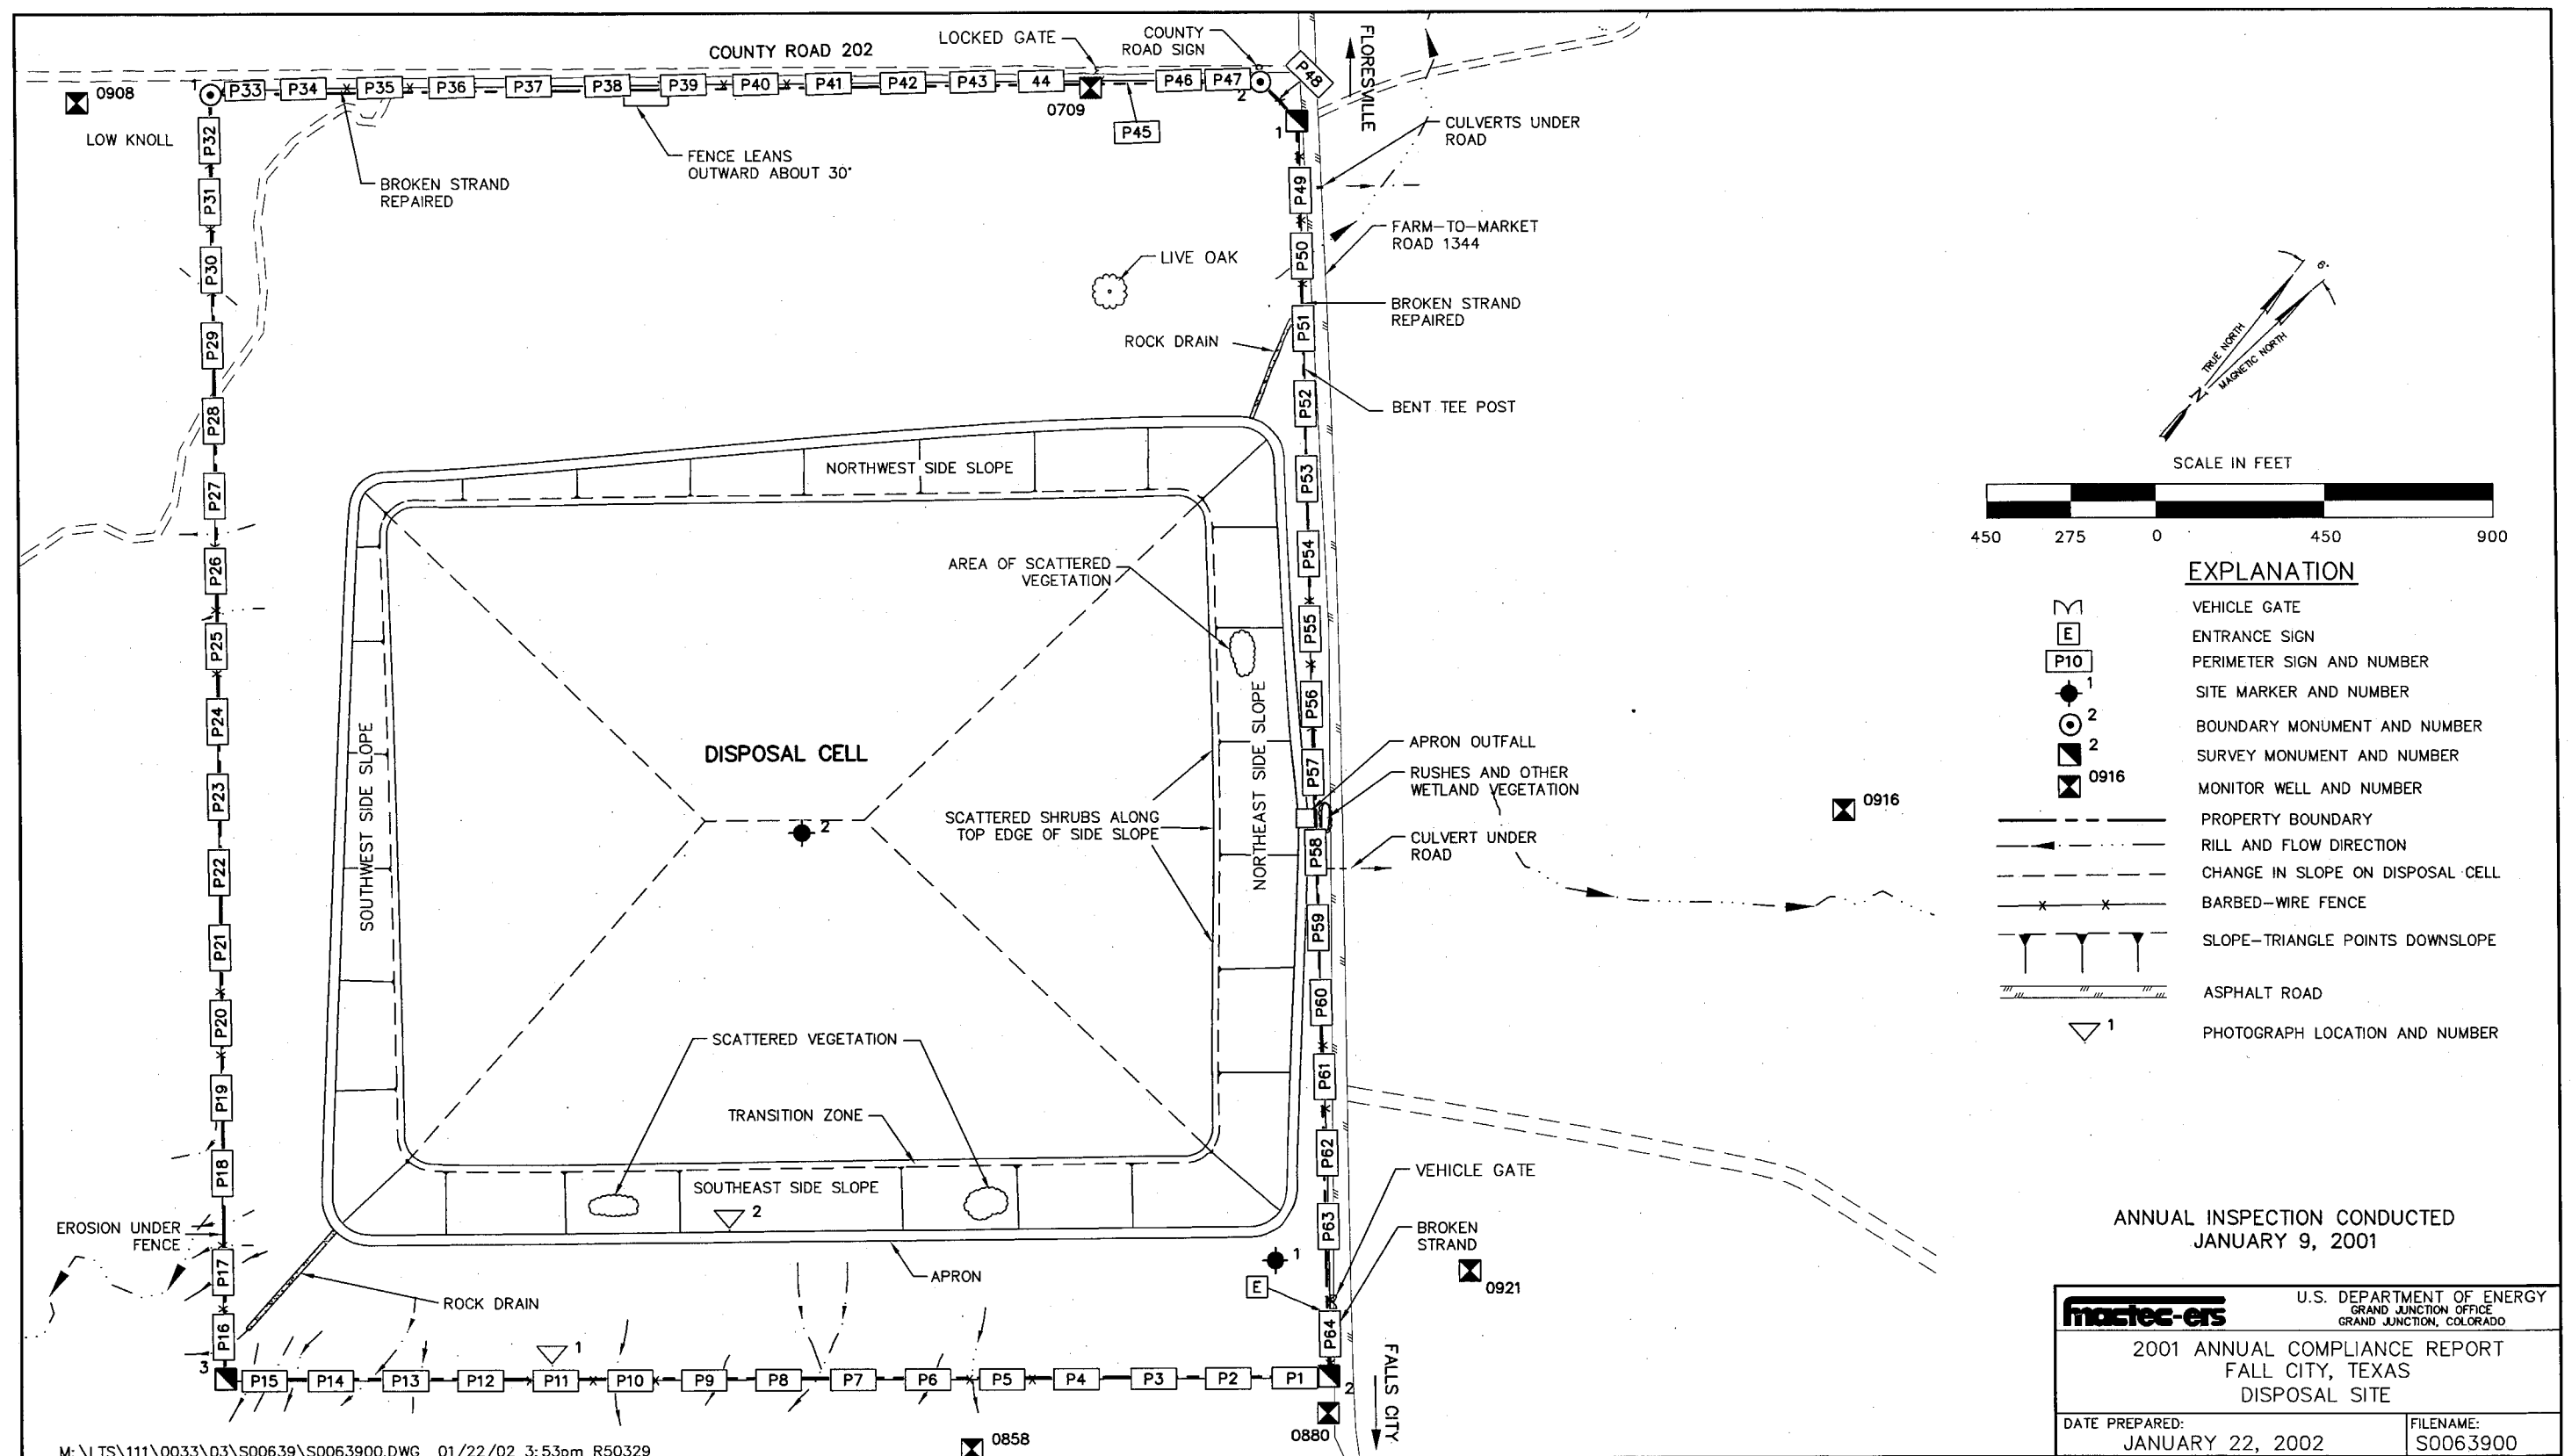
The side slopes of the disposal cell are armored with riprap, which overall is in excellent condition. Over the last 2 years, inspectors have noted that a very small percentage (less than 1 percent) of the riprap is cracked or broken (PL-2). It is not clear whether the cracks are recent or just recently noticed. None of the broken pieces appear to be more weathered or less durable than the unbroken rocks. Current assessment is that cracks are the result of stresses induced in the rock during quarrying and are not caused by chemical or physical weathering. Although inspectors will continue to note the condition of the rock, further cracking or breaking of the rock is not expected.
